> ALASKA (TER) DEPARTMENT OF HEALTH COMMUNITY FACILITIES IN ALASKA

Community Facilities

in

Alaska... PRESENT STATUS AND RECOMMENDATIONS

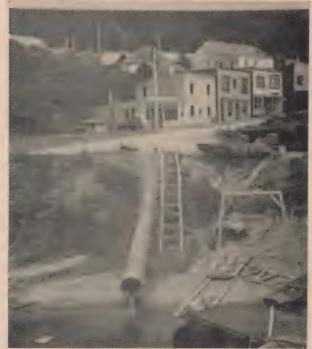
This sewer outfall in Cordova, Alaska, is typical of many to be found in coastal towns throughout Alaska. Such outfalls should be extended to a point below the low tide mark.

In several instances, the sewer outfalls are inadequate in length and size, or unsuitably located.

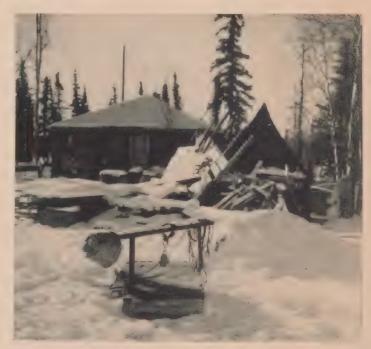
wells and cisterns are located in close proximity to actual or potential sources of contamination, such as privies, cesspools and sewer outfalls.

Open wells, such as this one located near the center of Alaska's largest city, are customary sources of water in many communities throughout the Territory.

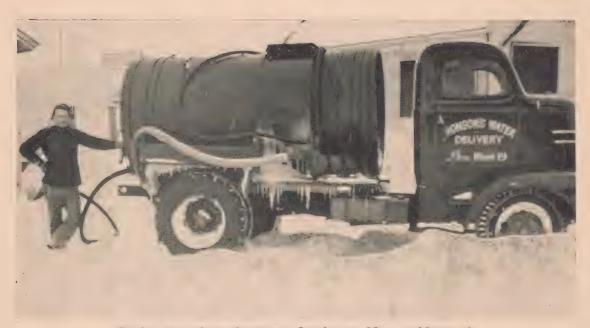
During the winter freeze-up, October to May, residents of Nome, Alaska, have their water supply delivered to the door by trucks such as this one.

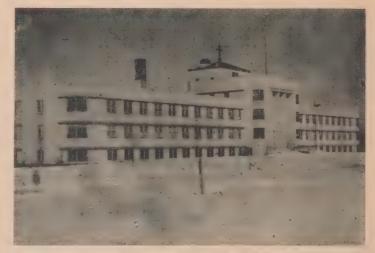
Providence Hospital, Anchorage, Alaska. Completed in 1939. (76 beds.) Inadequate for present and future needs.

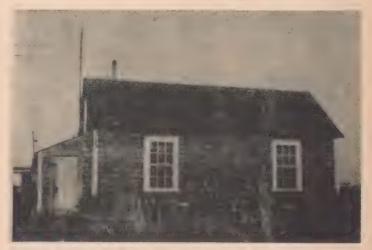
Health Center, Naknek, Alaska. Houses both health center facility and living quarters for public health nurse. Inadequate to meet present needs.
